Thermographic Investigation Report

Customer: H.I Konzern
24356 Ocean Place Redwood City Ca

Investigation Date: November 31, 2004
Jeff Frishof, President, Level 1 Thermographer

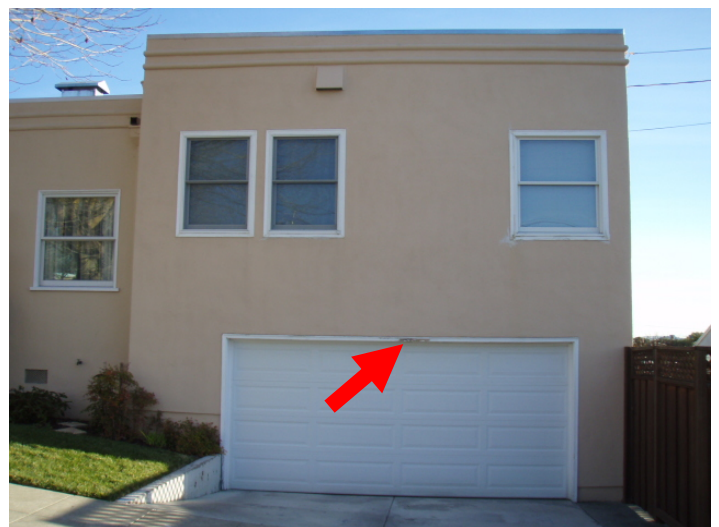
1.1 The investigation began at approximately 16:30 on the afternoon of November 31. The investigator examined the wall cladding and trim above the garage vehicle door for signs of cracking and moisture damage. It was observed that water was exiting from the trim around the vehicle door at the area identified by a **red** arrow in the photo to the left.

1.2 Investigation of the stucco above this area revealed no signs of visible cracking that could be associated with moisture entry. The trim around all three windows was examined and the materials were discovered to be soft to the touch, common with extensive exposure to moisture.

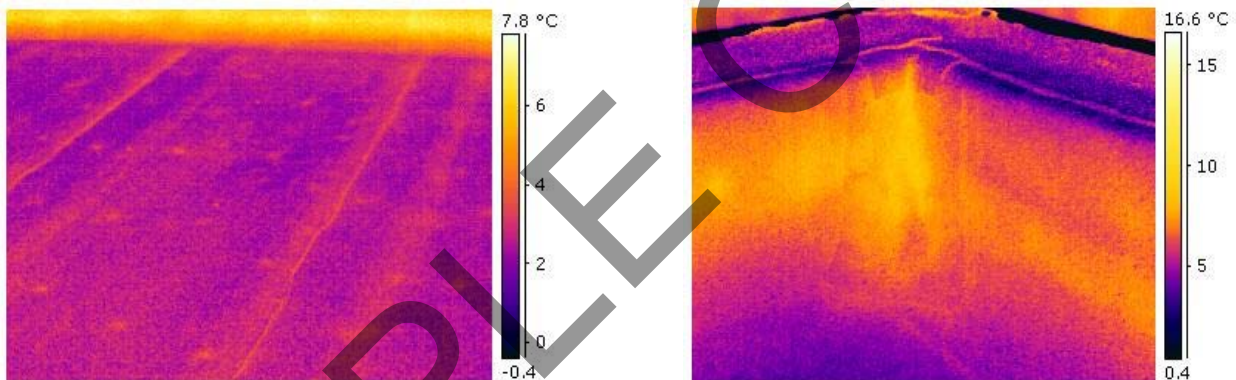
1.4 It was then decided that the roof area above this location should be inspected for any signs of tears, holes, or other reasons for moisture to enter the wall system in this area. With access to the roof, the material in our opinion has been installed within the past 1-2 years and was a membrane material single ply or modified bitumen installation overlapped approximately 3 inches and sealed with oil at all locations. Thermal images taken of this area does not reveal any areas of concern at this time.

1.5 The images above are of the overall surface material installed on the low slope roof systems (left image) and of coverage of the parapet wall (right image). Any lighter portions of the image are a result of solar loading of the materials and not of any concern at this time. With this type of material and roof installation, it is important that the homeowner retain a qualified roofing contractor to inspect all seams periodically for needed repairs. Our recommendation would be minimally inspect the surface materials every 3-5 years in the first 10 years and yearly thereafter. Drainage which is through the parapet walls and exits into scupper and downspouts should be cleared of debris prior to the local rain season and inspected monthly through the rain season.

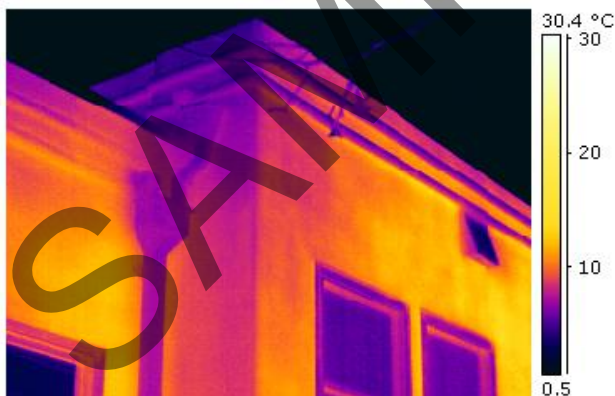
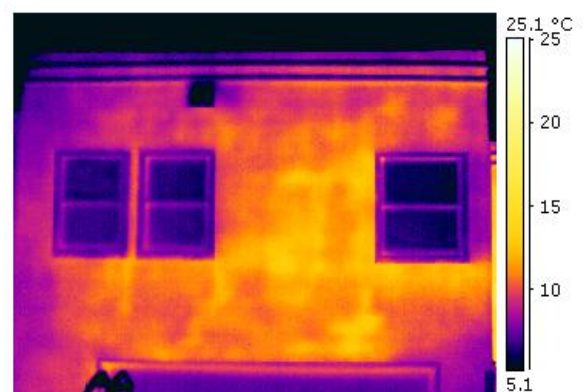
Initially imaging in the above left image of areas **A1** and **B1** would indicate no evidence of areas of concern. This image was taken at approximately 16:45. The image on the right is of the full area above the garage vehicle door which was taken at approximately 17:00 and areas identified as **B-3&4** and **C-3&4** as identified on the exterior map photo do indicate areas of concern.

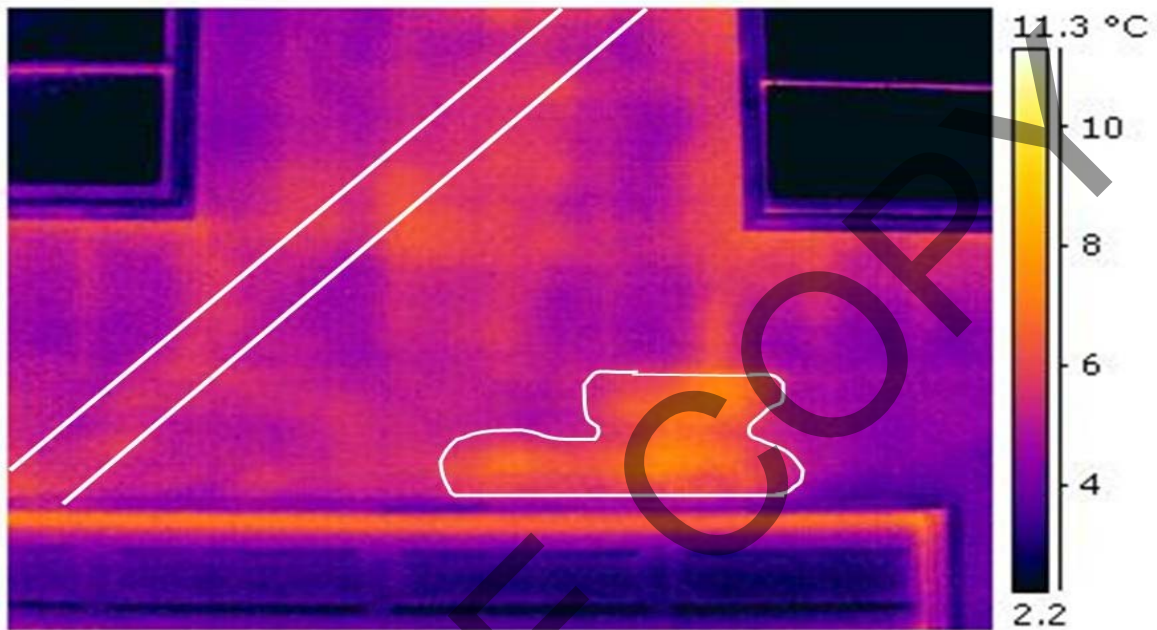
2.2 The infrared image above which was taken at approximately 18:00, diagrams an area as identified by the two straight white lines that in the opinion of the inspector indicates a cross brace within the wall. The cross brace which is a standard timber and would be of denser materials would be less likely to dissipate heat easily. For this reason it would tend to conduct a higher level of temperature to the exterior wall cladding. This is the same cause for the lighter regularly shaped vertical areas in the image as well. It would be possible for moisture to travel this diagonal timber. This could only be verified by destructive testing.

2.3 In the same image above in location **C-4** as identified on the exterior map photo, the irregular pattern in our opinion is an area that exhibits an elevated level of infrared energy. Either an air pocket or moisture trapped behind the stucco could easily cause this unusual pattern.

4.4 Upon the removal of the block trim the WRB should be investigated to determine if liquid water is being transferred behind the barrier materials. It is also our recommendation that the area in area C-4 as identified on the exterior map photo should have a test opening of approximately 12" x 12" be created to discover if as suspected, liquid water is draining into this area from the window components and repairs dependent upon those findings should follow accepted trade/code standards.

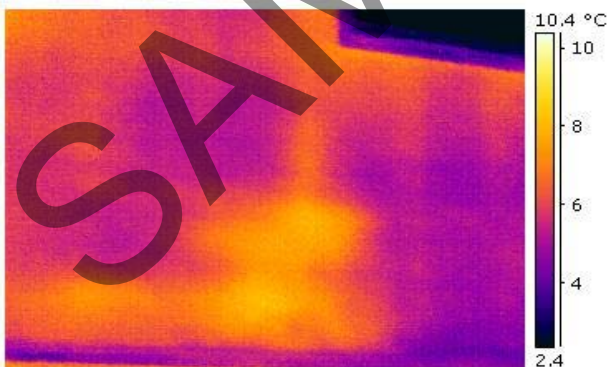
The image to the left is close up of area **C-4** in which the irregular pattern is more observable.

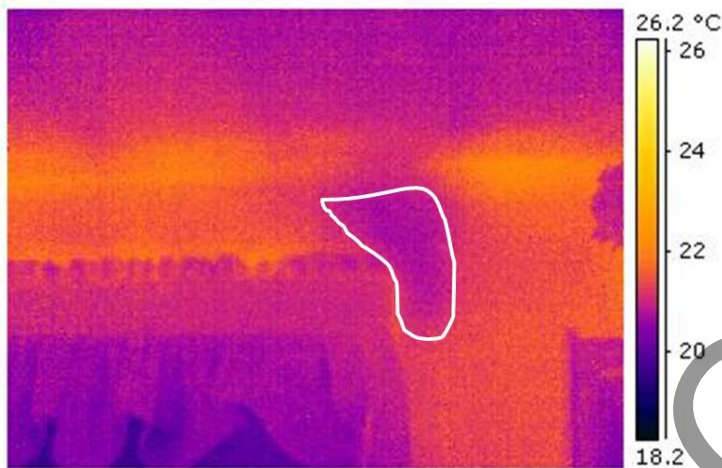
3.2 The image at the left is taken from the interior of the right bedroom if viewed from the exterior of the home. This is behind the area identified as A-5 on the exterior map photo and is just above the window. Although the darker shading would indicate cooler surface temperature, verification with a surface moisture meter did not indicate elevated levels of moisture. Lack of insulation or some form of void connecting to the attic may be a possible cause.

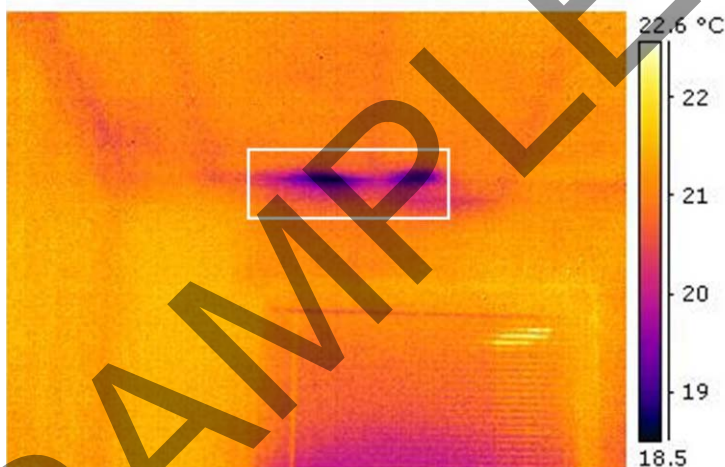
3.3 The image at the right is taken from the left bedroom if viewed from the exterior and identified as A-3 on the exterior map photo. This cooler or darker area is associated with a vent on the exterior. See the digital image of the exterior. Since this would vent the cavity between the interior ceiling and roof deck, no concern is to be raised by this image.
