# Inspection Report

Report # 20911-24

**The 45 Tesla Court, Menlo Park Ca 94003 Report**

Inspected on 10/10/2009

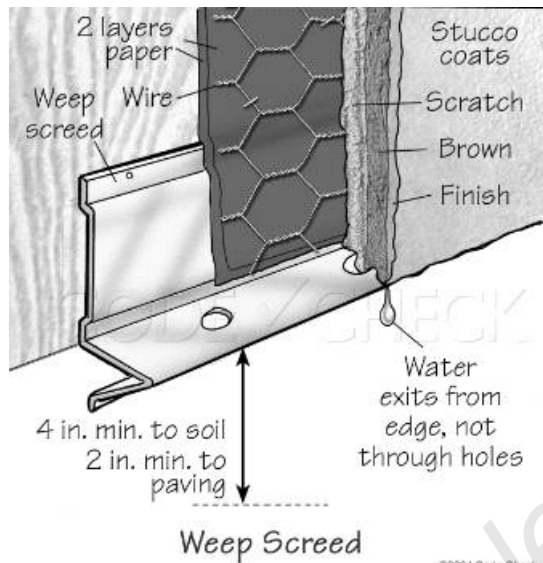
### STUCCO CLADDING

[RU] This building was built in an era before weep screeds were installed at the visible bottom edge of the stucco siding and clearance to exterior grade was required. The stucco siding materials were observed to extend into the soil or below the finished exterior grade. This condition is no longer permissible under currently accepted trade/building standards due to the potential for water to wick up out of the soil which can cause deterioration to wood framing members.

**Recommendation:** It is recommended that every effort be made to minimizing moisture around the building exterior to help protect the stucco and the structural components from moisture damage.

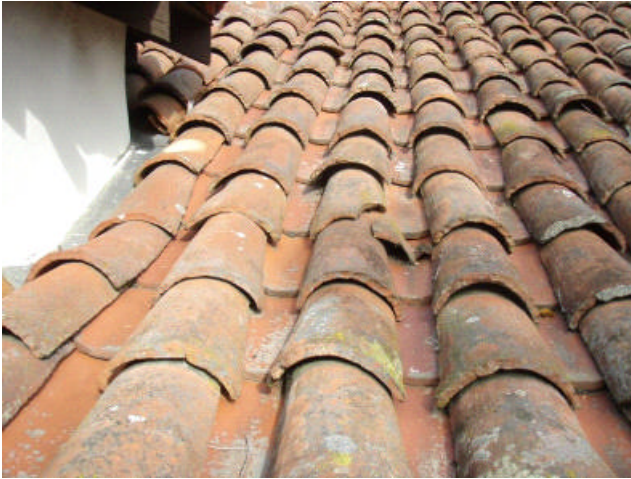
### CONCRETE OR SIMULATED TILES

[CR] It was observed that a number of tiles at several locations were cracked and in need of repair.

**Recommendation:** Correction is recommended.

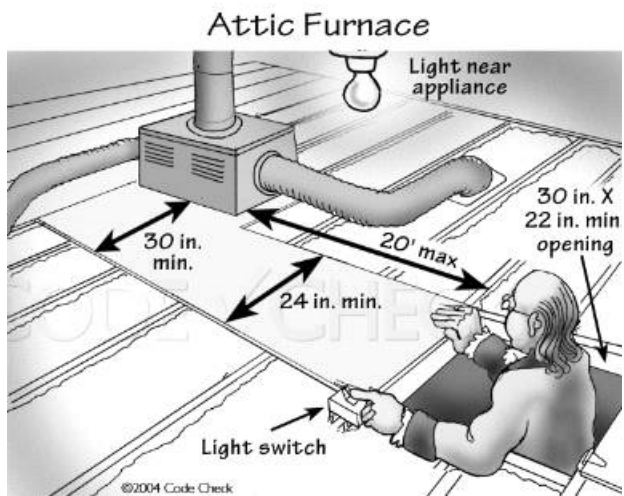
### LOCATION

[CR] Because the unit was located within the attic area, a permanent walking surface and service platform should be located near the unit for a service person to operate from. No permanent platform and walking surface was found as required.

**Recommendation:** It is recommended that this be corrected to conform with current residential building standards. This prevents access for inspection.

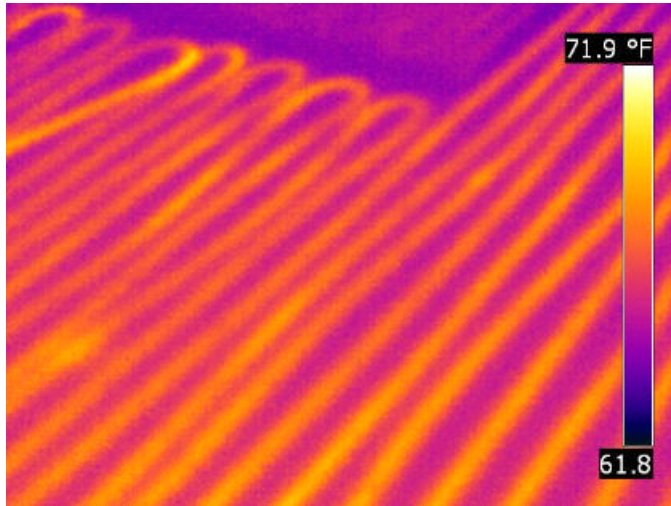
## RADIANT ELEMENTS

Within the bath areas, the radiant floor heating was verified as functional with the use of a thermal imaging camera. Any service or repair should be by a qualified specialist only.

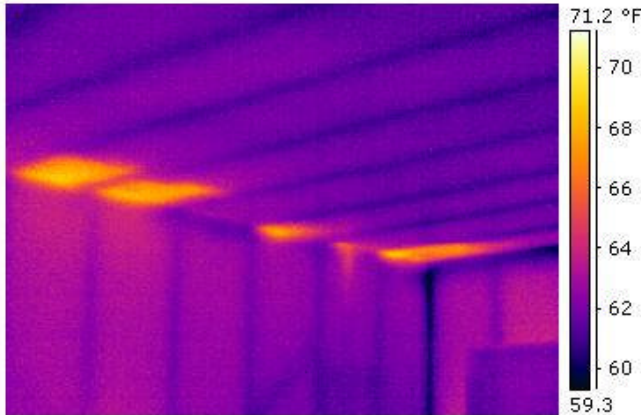
## WALL INSULATION

By use of an infrared camera, it was observed and we have provided below images that there are areas where insulation may be missing or more may be needed. Contact a insulation contractor in your area to determine how to improve the energy efficiency of the home.
