# Inspection Report

123 Whatahouse Rd Woodside, Ca 94062

Inspection Date: 03/10/2017

Report # 201703-064

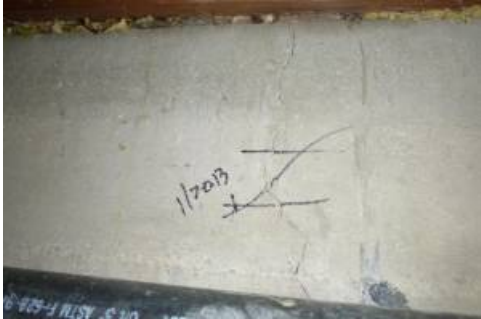
[CR] The concrete foundation had evidence of moderate cracking or cracks that were wider than 1/8 of an inch. This may be due to settlement/movement of the supporting soils at a number of locations.

**Recommendation:** While it would be expected that an older home such as this would have some cracking present, it is recommend the noted conditions be further evaluated and corrected by a specialist in the appropriate trade such as but not limited to a geotechnical/structural engineer.

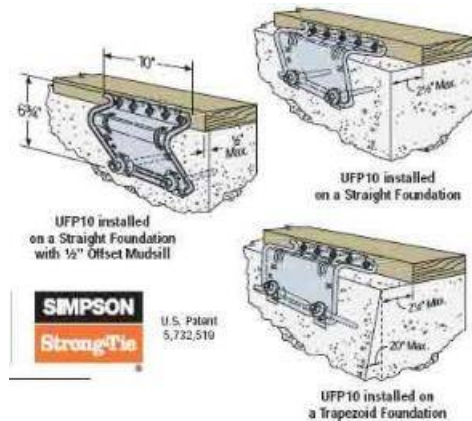
## ANCHORING & BRACING

[RU] The foundation anchor bolts or the hardware designed and installed to anchor the mudsill to the foundation is judged by current residential building standards to be minimal. Current standards call for anchoring to be spaced at no more than 6 feet apart and that bolts should be a minimum 1/2 inch diameter and possibly with larger washers. There may also be additional hardware requirements for structures that are in excess of a single story/level.

**Recommendation:** It is recommended you consider the installation of additional anchoring, wall bracing (if exterior walls are impacted) and/or seismic connectors as a foundation upgrade and part of home improvements. This may be required if additions or modifications to the structure are made.

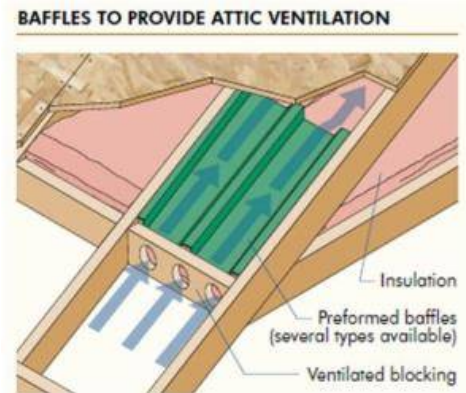
[RU] Although the insulation materials were not blocking the vent openings, it is important that this does not occur. Baffles at this location can allow insulation to cover the ceiling framing to wall connection while also allowing air flow at the vent.

**Recommendation:** As part of property improvement, installation of a baffle at all eave openings should be considered.

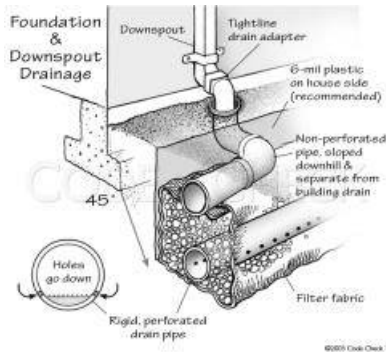
**SITE DRAINAGE**

[RU] Current trade standards for construction would dictate that the installation of roof and/or surface drainage system will prevent moisture damage to the structure and/or collection of water in the under building crawl space areas. This home does not currently have such systems.

**Recommendation:** Review of statements made in other portions of the report along with consideration to the installation of a drainage system is our recommendation as part of property improvements. Since installation of drainage systems can have an effect on the structure a detailed study by a drainage specialist should be conducted before any changes are made.

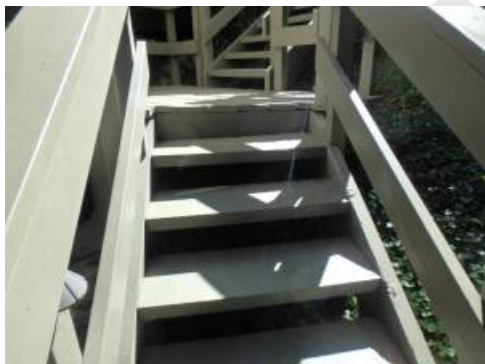
[CR] It was noted that the wooden stairs on the exterior of the structure were open tread/risers with spacing in excess of 4 inches. While this may have been approved at the time of original construction, this is considered a tripping hazard due to the amount of opening between treads.

**Recommendation:** Consideration to upgrading of the steps/stairways to conform with current building standards is recommended.

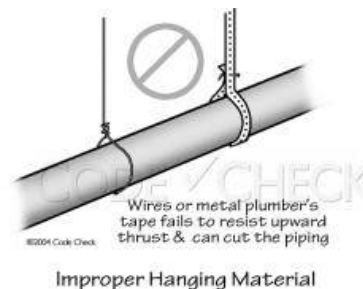
[CR] The metal supports used to support the PVC plastic drain lines were installed without a protective shield to prevent damage to the piping during expansion/contraction of the pipe.

**Recommendation:** Either replacement of the brackets with plastic support brackets or the addition of protection at the pipe is recommended. Spacing of the brackets should not exceed 4 feet.

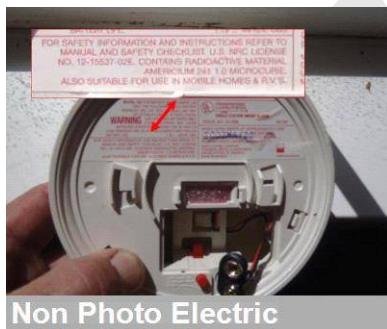
#### SMOKE ALARMS

Non Photo Electric

[NOTE] A smoke alarm/detection device was present where currently required. To examine or test smoke alarm/detectors for function is outside the scope of the inspection. It is recommended that once the home is occupied that the smoke alarm/detectors be tested by the client and all batteries (if so designed) be replaced. Any alarm/detector battery should be replaced at least twice a year. It is most convenient at the same time as the daylight savings time changes. Additionally, studies have shown that of the two different types of devices on the market, one type uses a photo electric sensor and the other uses an ionization method. The photoelectric device is by far the more reliable for the early detection of smoke or smoldering fires. Some jurisdictions no longer approve the ionization type. Your local building department should be contacted for further information.
