Residential Electrical System -Aging Research Project

Technical Report

July 1, 2008

Underwriters Laboratories Inc.

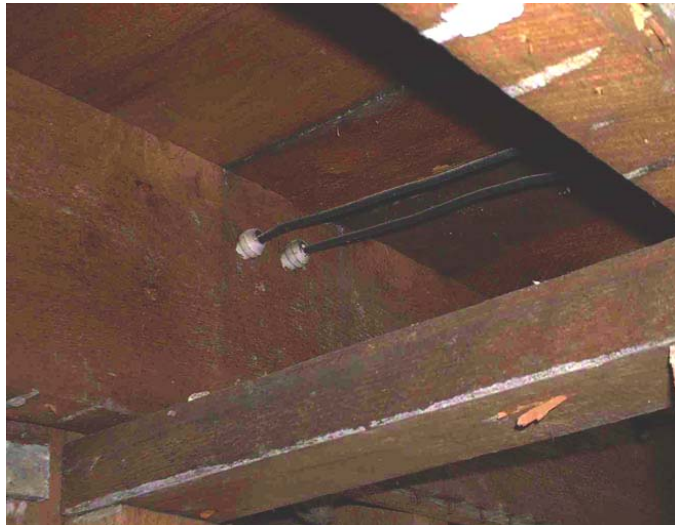
Fig. 1a – Knob-and-Tube Wiring From House IL-6

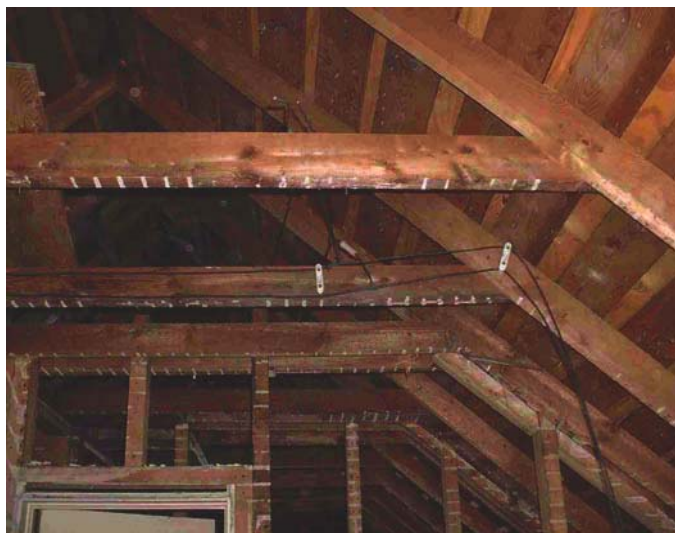
Fig. 1b – Knob-and-Tube Wiring From House IL-6
