# Federal Pacific Electric

Douglas Hansen & Redwood Kardon

(last updated 11/28/2012)

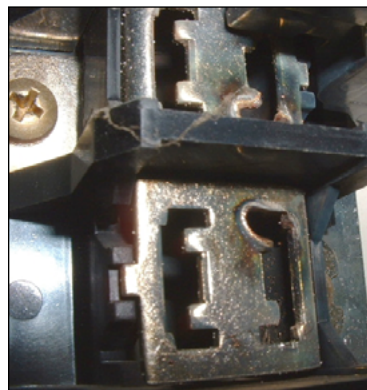
**Figure 4 - Aluminum Sockets**

Early FPE equipment had copper bus bars with the sockets cleanly defined (figure 3). Later FPE equipment used plated aluminum, which appears to have been stamped (figure 4). Some edges of the socket opening are slightly bent on these later models, further reducing the contact area of the breaker to bus connection.

Damage such as seen in figure 4 is quite common, though it cannot be seen until the breakers have been removed.

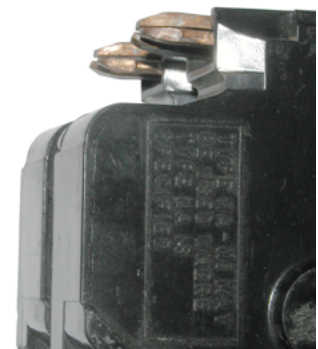
**Figure 6 - 2-pole F Breaker**
