Thermographic Investigation Report

Customer: H.I Konzern
24356 Ocean Place Redwood City Ca

Investigation Date: November 31, 2004
Jeff Frishof, President, Level 1 Thermographer

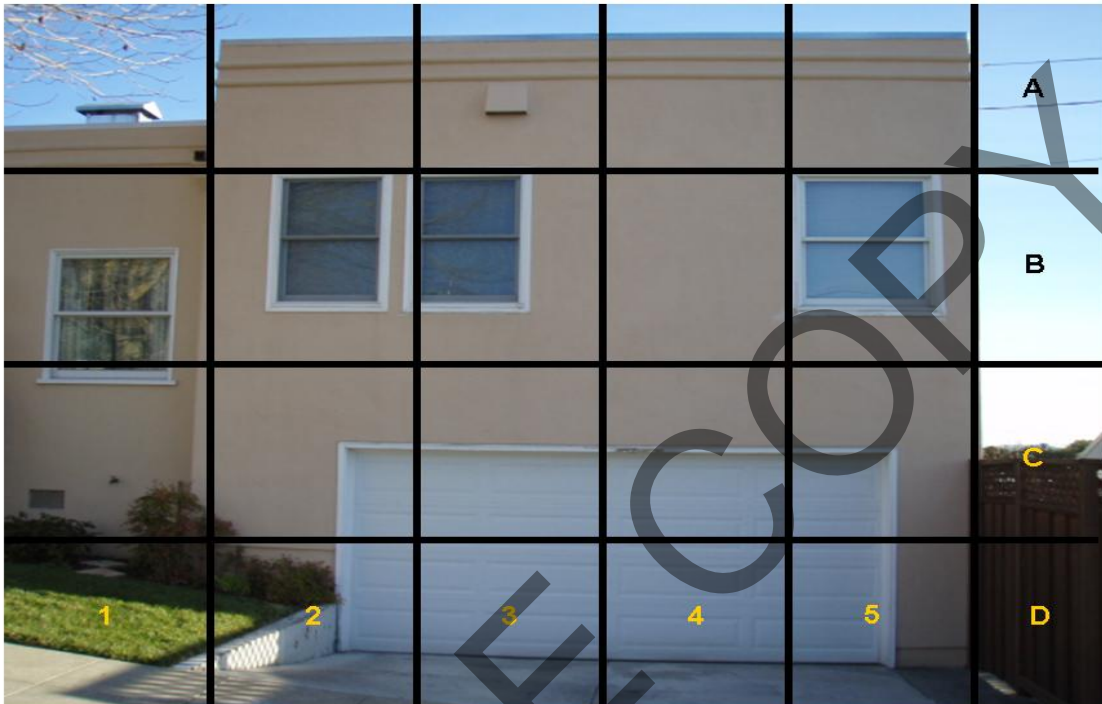
Post Sunset

2.1 Once the sun had set the inspection was begun using thermal imaging to investigate the area above the garage vehicle entry door to observe for potential pockets that could allow moisture to collect behind the cladding. In the following thermal images refer to the site map above for location identification.

2.2 The infrared image above which was taken at approximately 18:00, diagrams an area as identified by the two straight white lines that in the opinion of the inspector indicates a cross brace within the wall. The cross brace which is a standard timber and would be of denser materials would be less likely to dissipate heat easily. For this reason it would tend to conduct a higher level of temperature to the exterior wall cladding. This is the same cause for the lighter regularly shaped vertical areas in the image as well. It would be possible for moisture to travel this diagonal timber. This could only be verified by destructive testing.

2.3 In the same image above in location **C-4** as identified on the exterior map photo, the irregular pattern in our opinion is an area that exhibits an elevated level of infrared energy. Either an air pocket or moisture trapped behind the stucco could easily cause this unusual pattern.

4.2 Our recommendation would be first to remove the window block trim boards and inspect the attachment and flashing detail of the installation. It is our belief that damage has occurred at the attachment flange or the installation of window flashing or that the flashings were not sealed/installed in accordance with accepted trade/code standards.

4.3 **Recommended Method.** The following is a method commonly used. Install self-adhered membrane sill flashing pans at both flanged and non-flanged windows, complete with interior upturned legs and permanently watertight end dams. Do not penetrate the horizontal surface of the sill pan and do not use sealants to form the end dams. Install continuous metal angles along the rough opening to serve as backing for membrane strip flashing and as attachment for non-flanged windows. At the jambs, turn the strip flashing into the rough opening and extend to the tip of the angle; shingle jamb flashing into the sill flashing pan.
